Fish Habitat Improvement Success Story

NEZ PERCE SOIL AND WATER
CONSERVATION DISTRICT

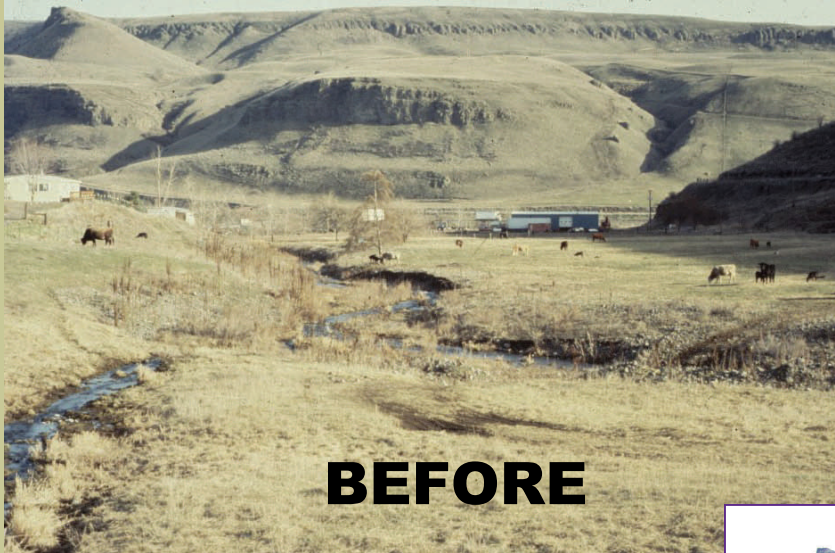
BEFORE

This project site is located on a tributary of the Lower Clearwater River. This photo was taken in 1992 prior to habitat improvement project implementation.

Habitat limitations at this site include high stream temperatures, lack of in-stream complexity, low summer flows, inadequate shelter, and sediment in stream.

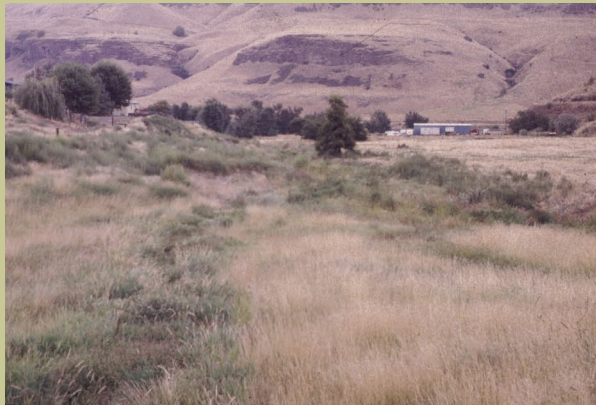
Photo taken in 1995 after installation of habitat improvement projects. Improvements included installation of a livestock water system, grass seeding, fencing, tree planting, log drop structures, habitat rocks, and brush mattresses.

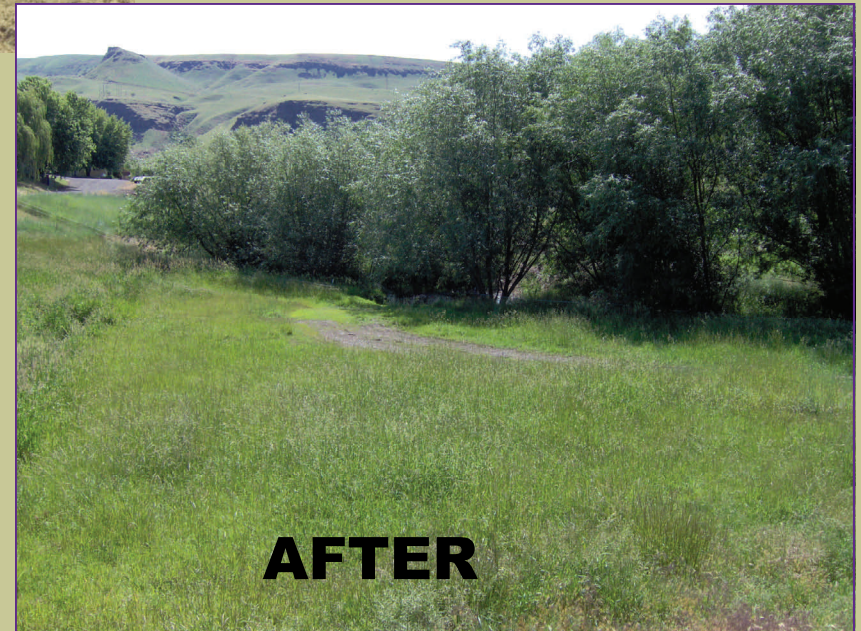
AFTER

June 2006—SUCCESS!!!
