Fish Habitat Improvement Success

**NEZ PERCE SOIL AND
WATER
CONSERVATION
DISTRICT**

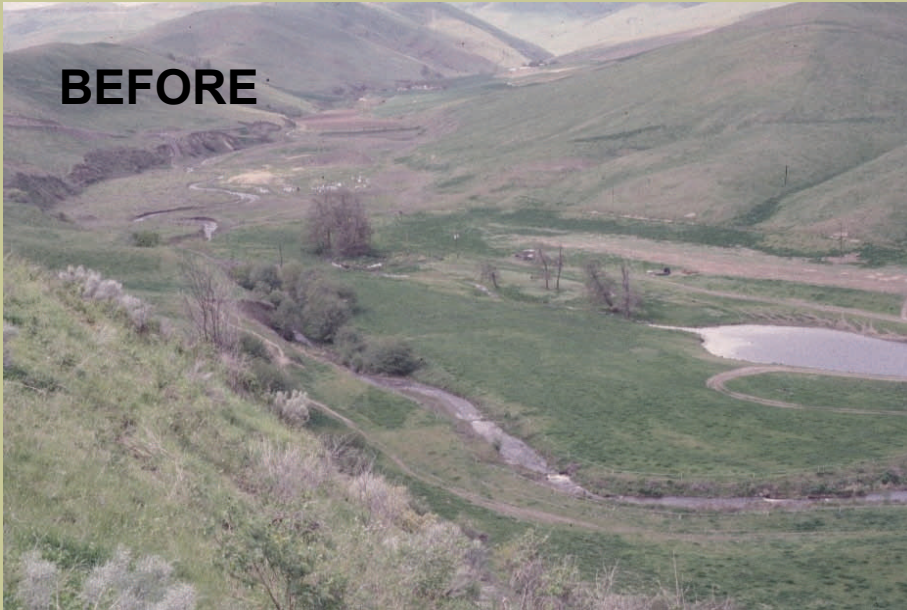
BEFORE

This project site is located on a tributary of the Lower Clearwater River. This photo was taken in 1992 prior to habitat improvement project implementation.

Fish habitat limitations at this site include high stream temperatures, lack of in-stream complexity, low summer flows, inadequate shelter, and sediment in stream.

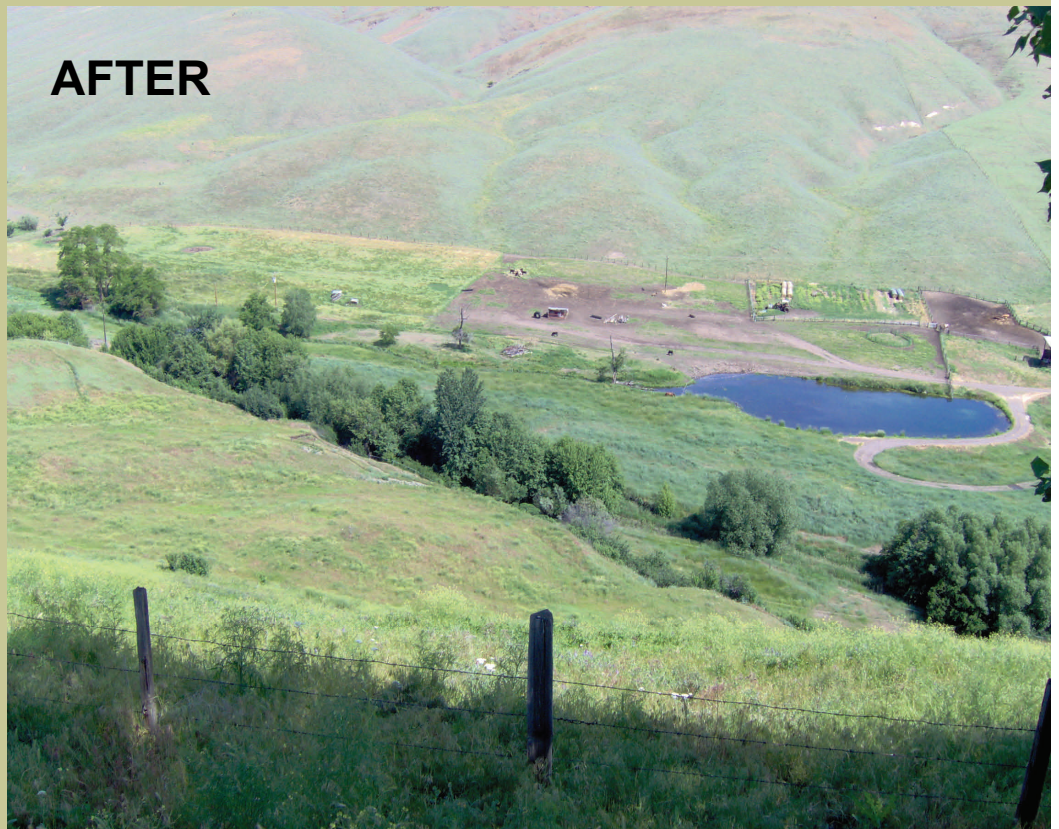
AFTER

Photo taken in 2006.
Treatments installed in 1992 and 1993 included fencing, livestock water system, grass seeding, pasture management system, drop structures, and tree planting.
